**SITE ASSESSMENT REPORT
FOR
TILTON PLATING
TILTON, VERMILION COUNTY, ILLINOIS
TDD No.: S05-9809-012
PAN: 8P1201SIXX**

December 1, 1998

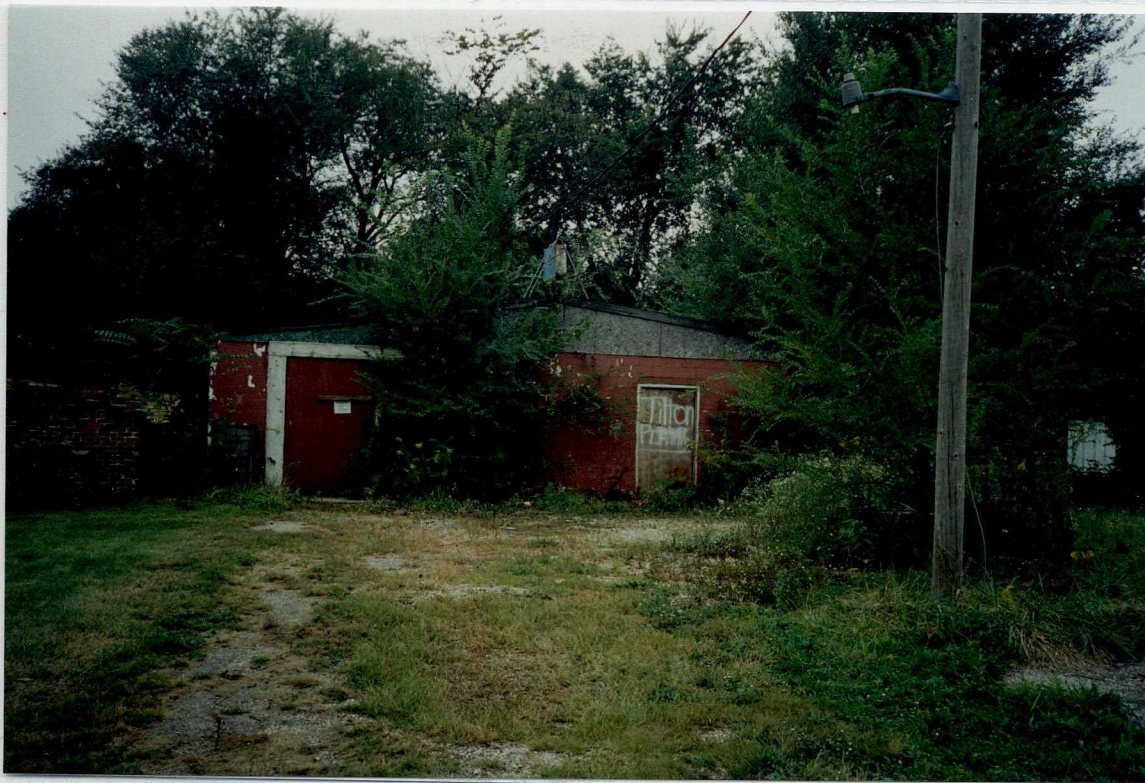
SITE: Tilton Plating **DATE:** September 25, 1998 **TIME:** 1045
LOCATION: Tilton, Illinois **DIRECTION:** West **PHOTOGRAPHER:** Bill Sass
SUBJECT: Front of building, brick building owned by resident, and shed (at far right).

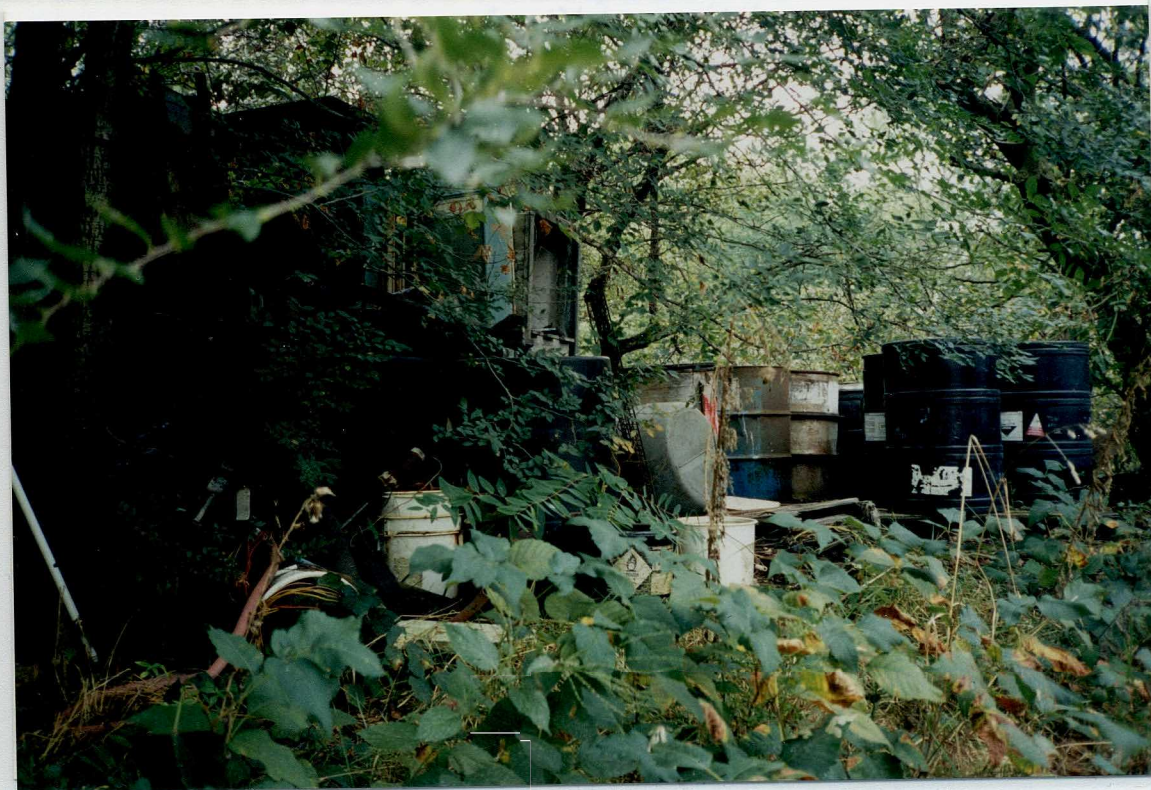
SITE: Tilton Plating **DATE:** September 25, 1998 **TIME:** 1046
LOCATION: Tilton, Illinois **DIRECTION:** West **PHOTOGRAPHER:** Bill Sass
SUBJECT: Drums north of building.

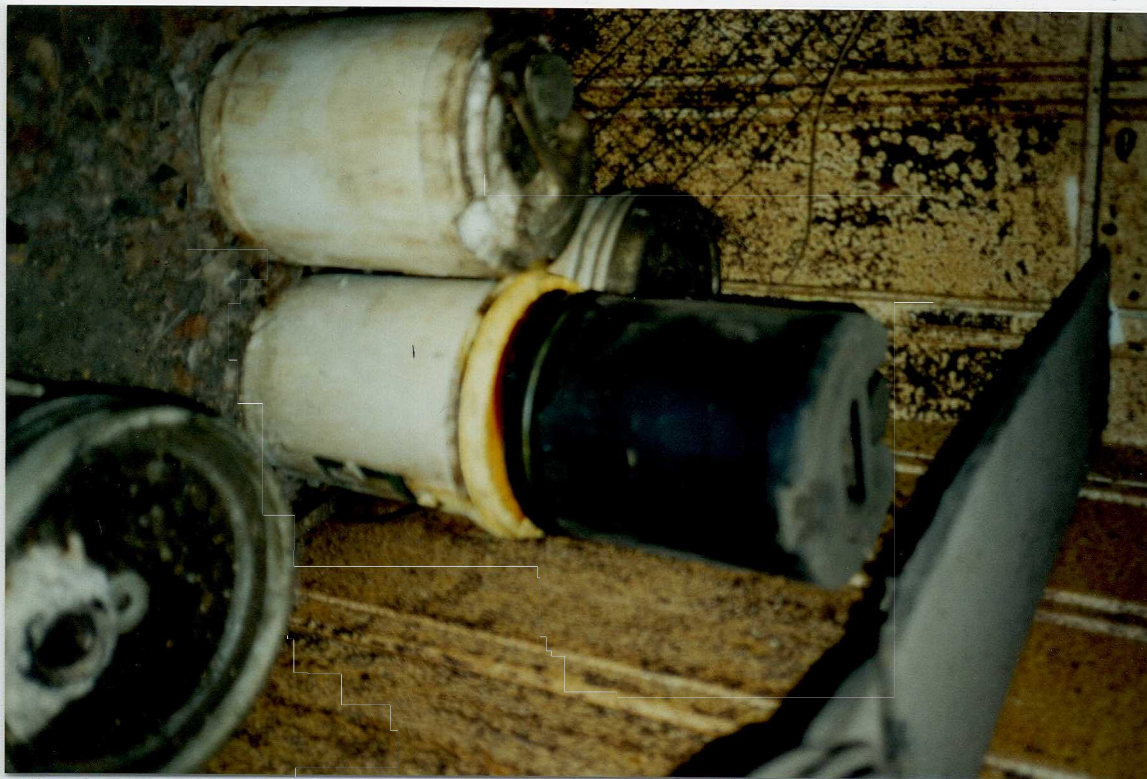
SITE: Tilton Plating
LOCATION: Tilton, Illinois
SUBJECT: Containers in small shed.

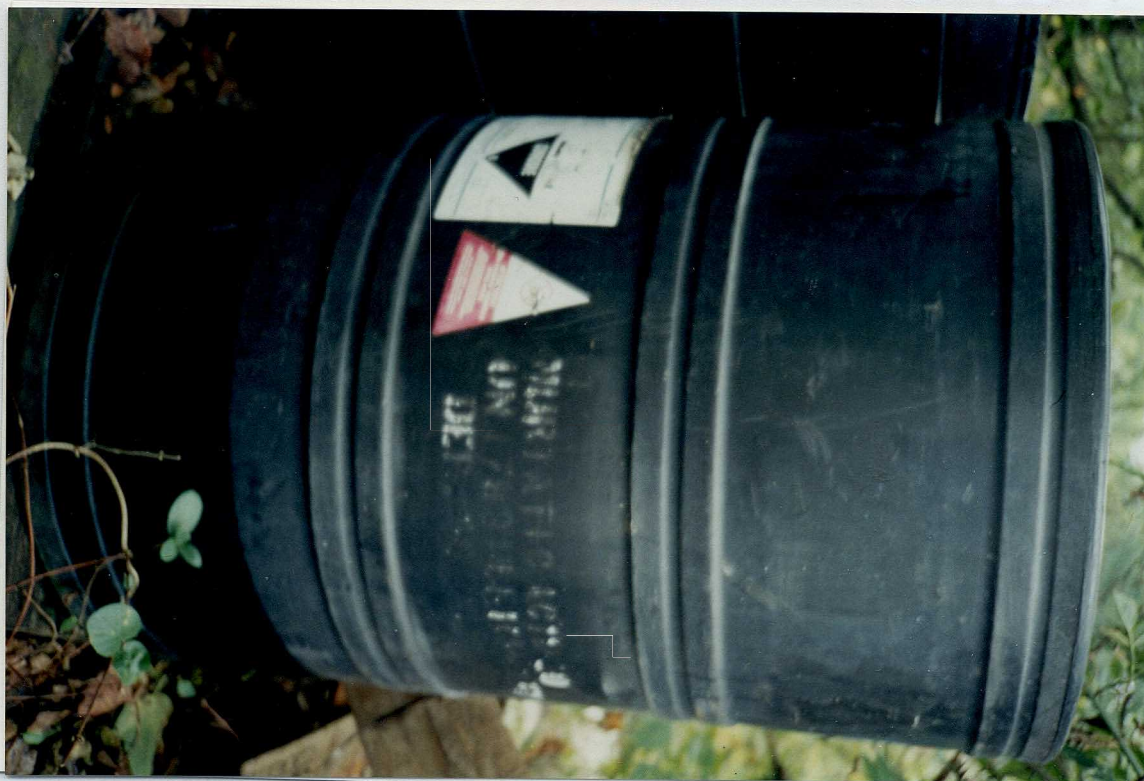
SITE: Tilton Plating
LOCATION: Tilton, Illinois
SUBJECT: Close-up of drum on north side of building. Drum is labeled "Muriatic Acid".

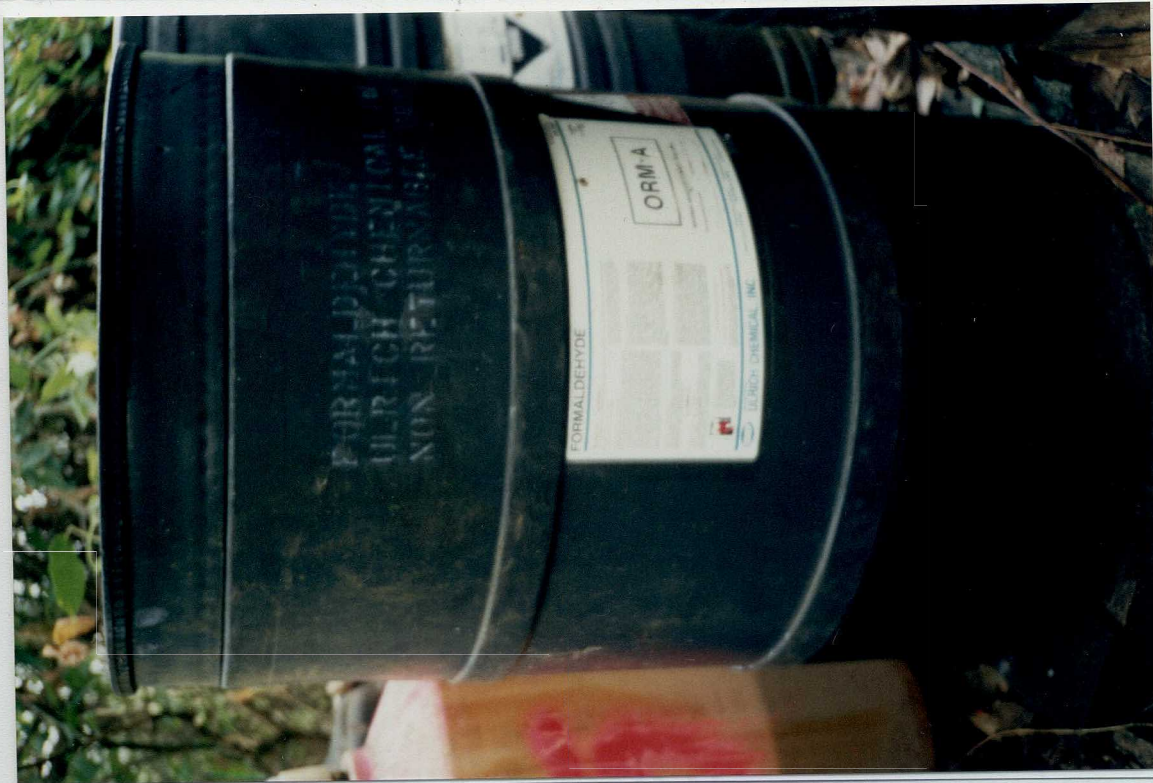
SITE: Tilton Plating DATE: September 25, 1998 TIME: 1047
 LOCATION: Tilton, Illinois DIRECTION: North PHOTOGRAPHER: Bill Sass
 SUBJECT: Close-up of drum on north side of building. Drum is labeled "Formaldehyde".

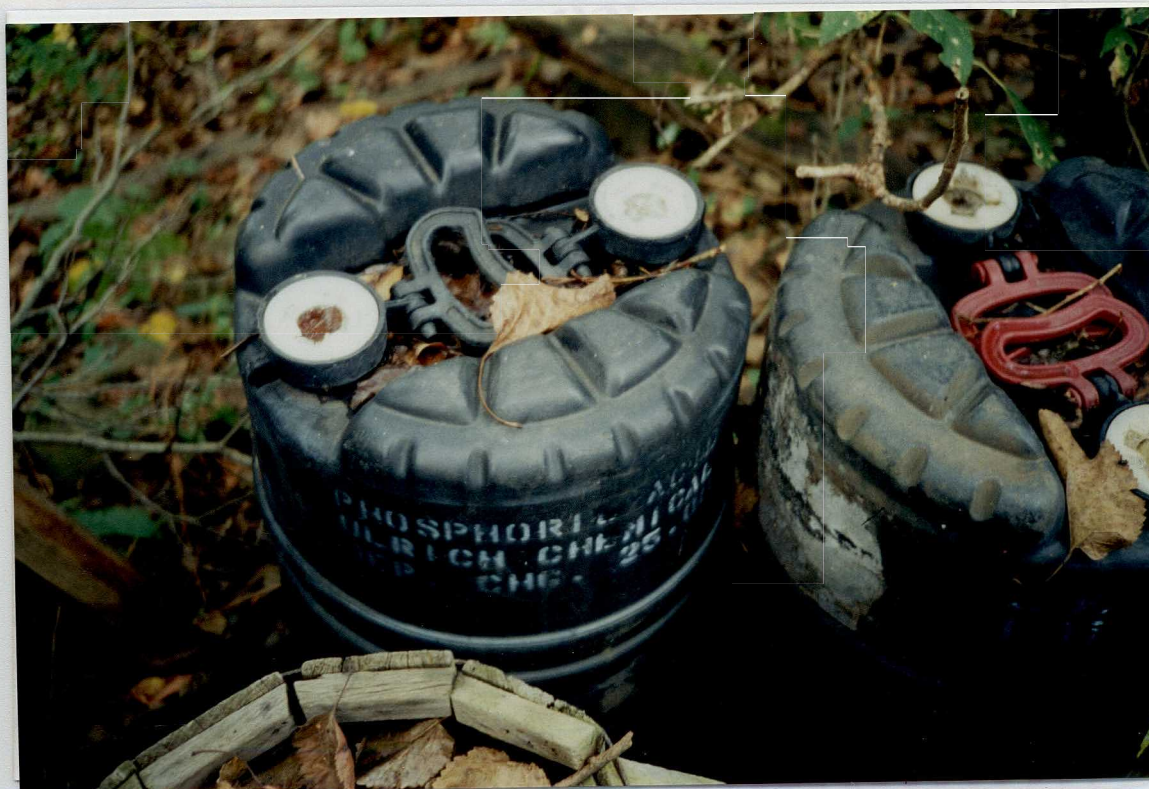
SITE: Tilton Plating DATE: September 25, 1998 TIME: 1047
 LOCATION: Tilton, Illinois DIRECTION: North PHOTOGRAPHER: Bill Sass
 SUBJECT: Close-up of container on north side of building. Container is labeled "Phosphoric Acid".

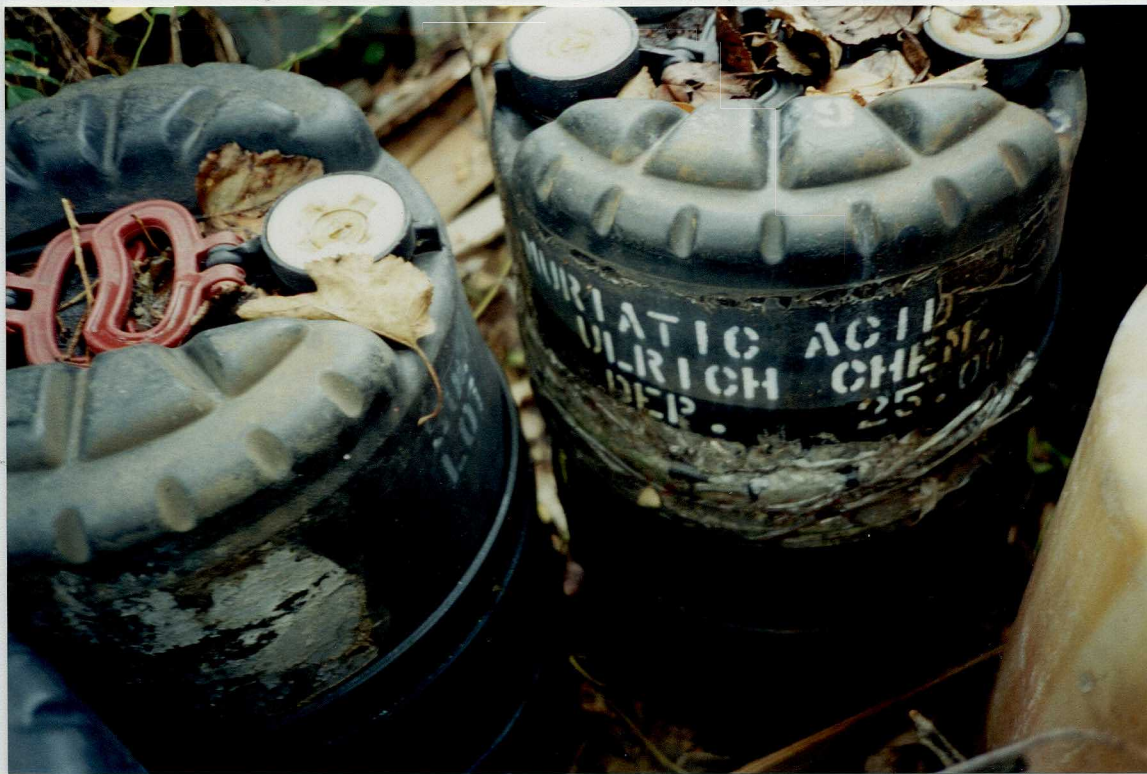
SITE: Tilton Plating DATE: September 25, 1998 TIME: 1047
 LOCATION: Tilton, Illinois DIRECTION: North PHOTOGRAPHER: Bill Sass
 SUBJECT: Close-up of container on north side of building labeled "Muriatic Acid".

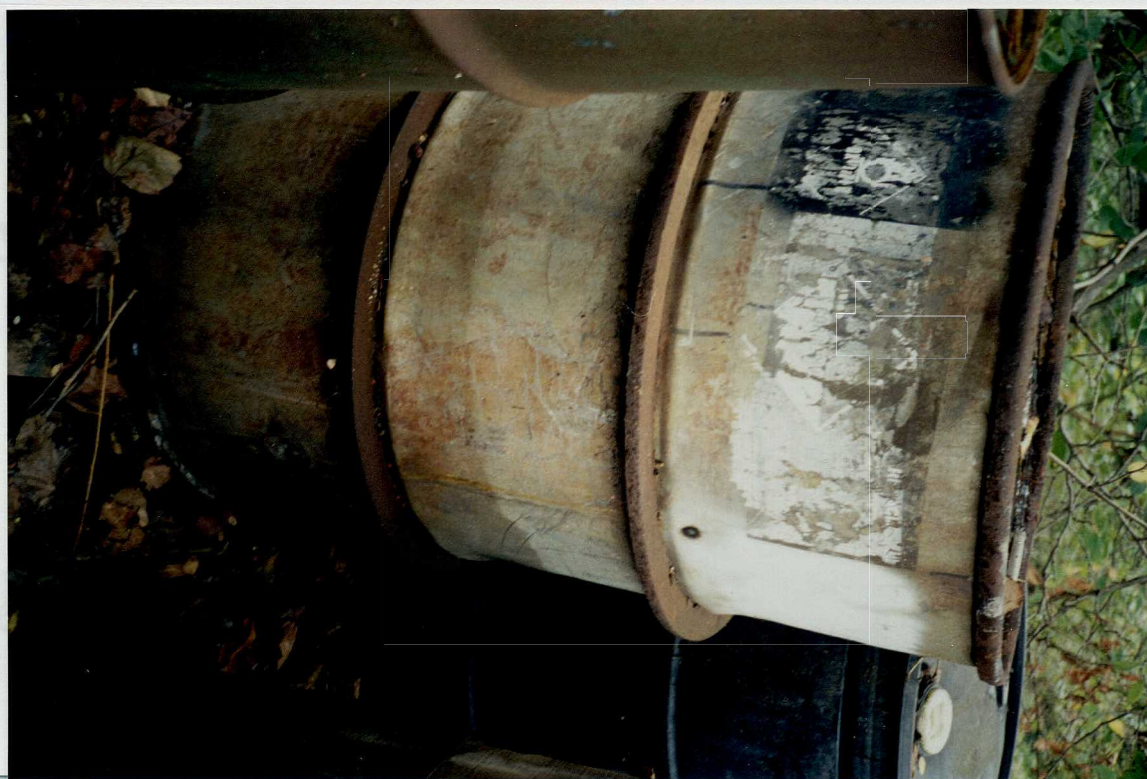
SITE: Tilton Plating DATE: September 25, 1998 TIME: 1048
 LOCATION: Tilton, Illinois DIRECTION: Northwest PHOTOGRAPHER: Bill Sass
 SUBJECT: Steel drum on north side of building.

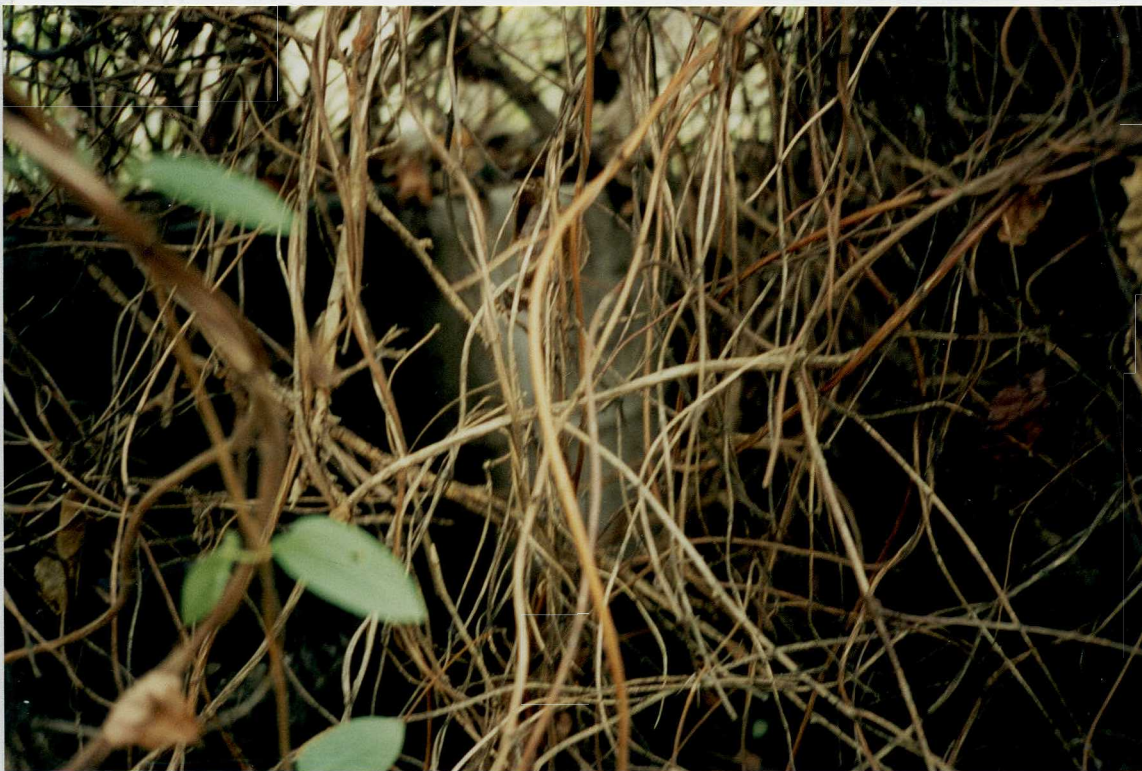
SITE: Tilton Plating DATE: September 25, 1998 TIME: 1049
 LOCATION: Tilton, Illinois DIRECTION: North PHOTOGRAPHER: Bill Sass
 SUBJECT: Drums hidden by foliage on north side of building.

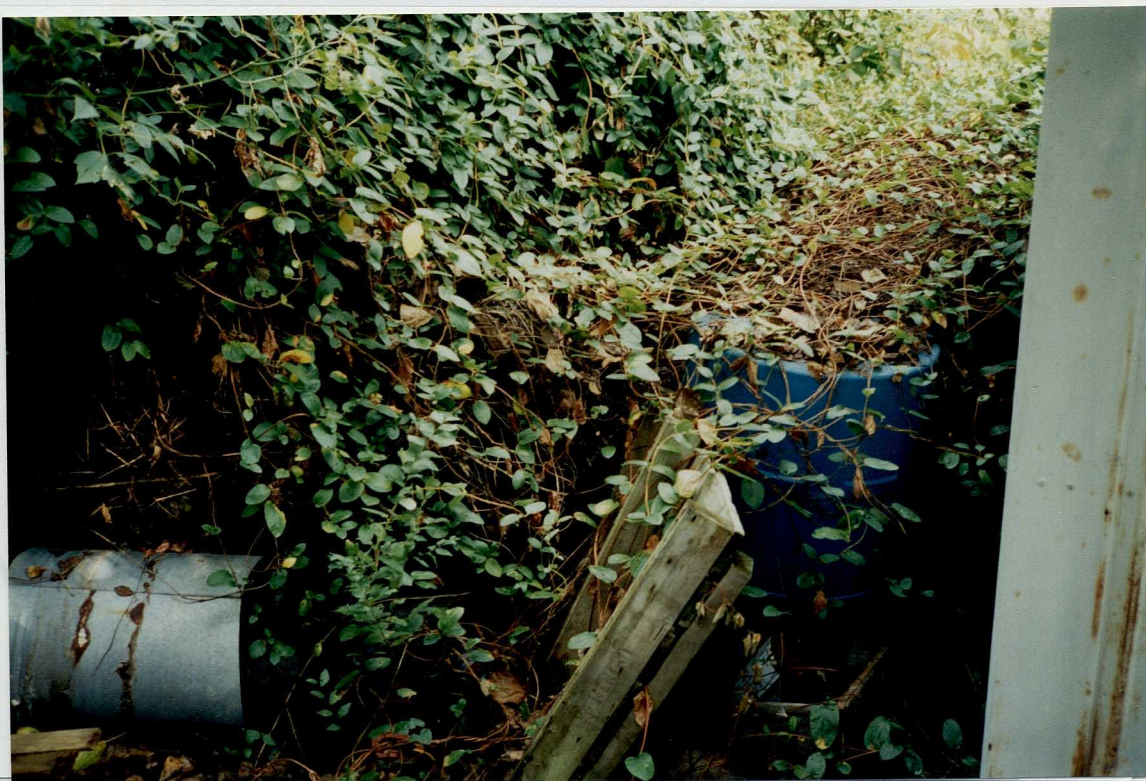
SITE: Tilton Plating DATE: September 25, 1998 TIME: 1050
 LOCATION: Tilton, Illinois DIRECTION: North PHOTOGRAPHER: Bill Sass
 SUBJECT: Drums hidden by foliage on north side of building.

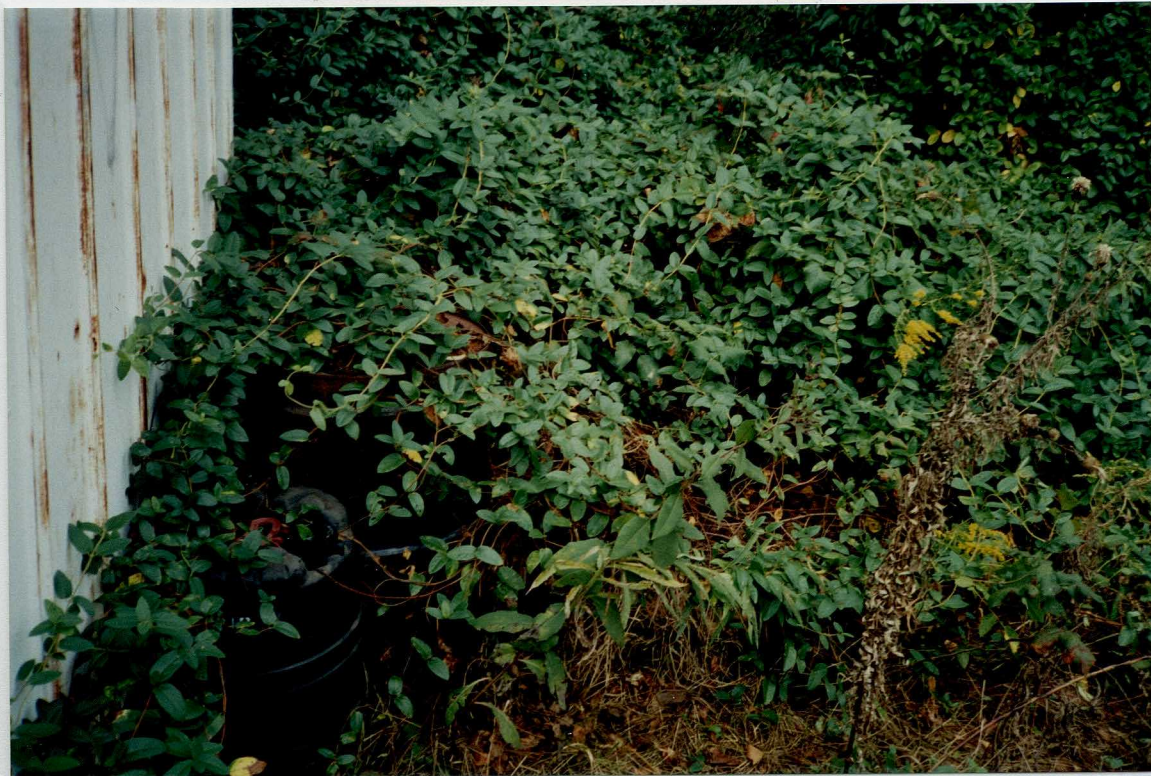
SITE: Tilton Plating DATE: September 25, 1998 TIME: 1050
 LOCATION: Tilton, Illinois DIRECTION: West PHOTOGRAPHER: Bill Sass
 SUBJECT: Drums and containers on north side of building.

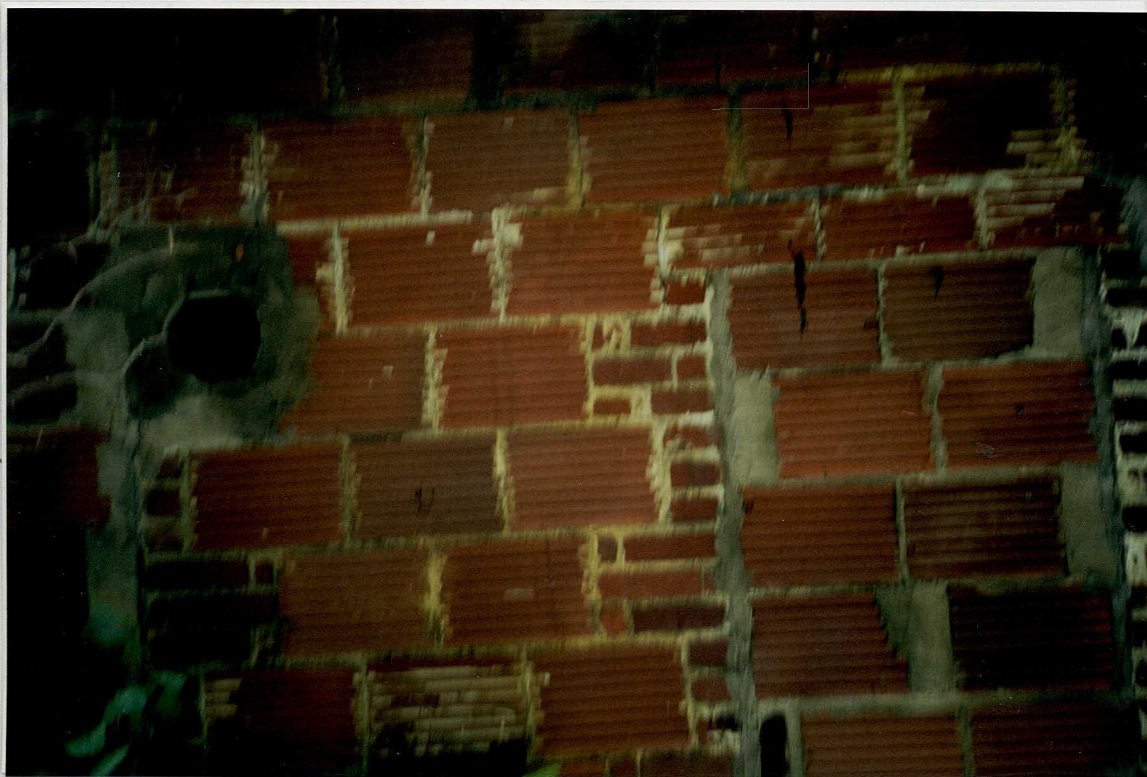
SITE: Tilton Plating DATE: September 25, 1998 TIME: 1052
 LOCATION: Tilton, Illinois DIRECTION: East PHOTOGRAPHER: Bill Sass
 SUBJECT: Hole in wall of building with yellow stain visible in brick mortar.

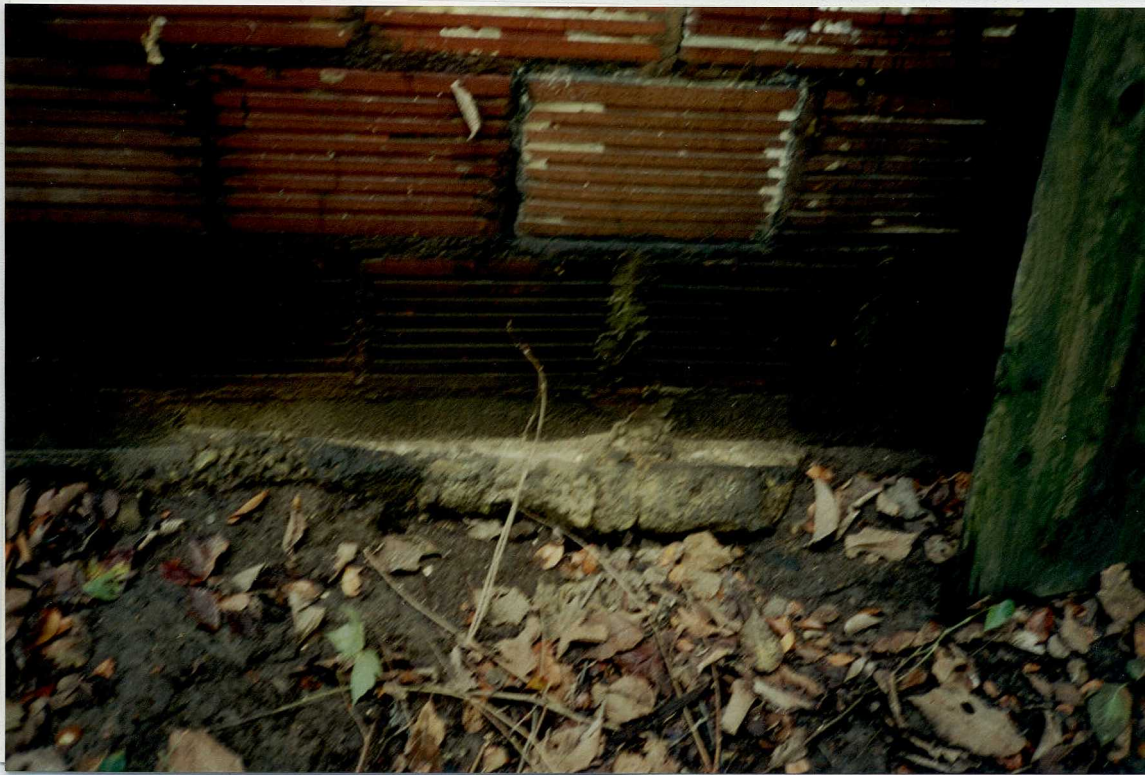
SITE: Tilton Plating DATE: September 25, 1998 TIME: 1054
 LOCATION: Tilton, Illinois DIRECTION: East PHOTOGRAPHER: Bill Sass
 SUBJECT: Close-up of possible leakage point along west wall.

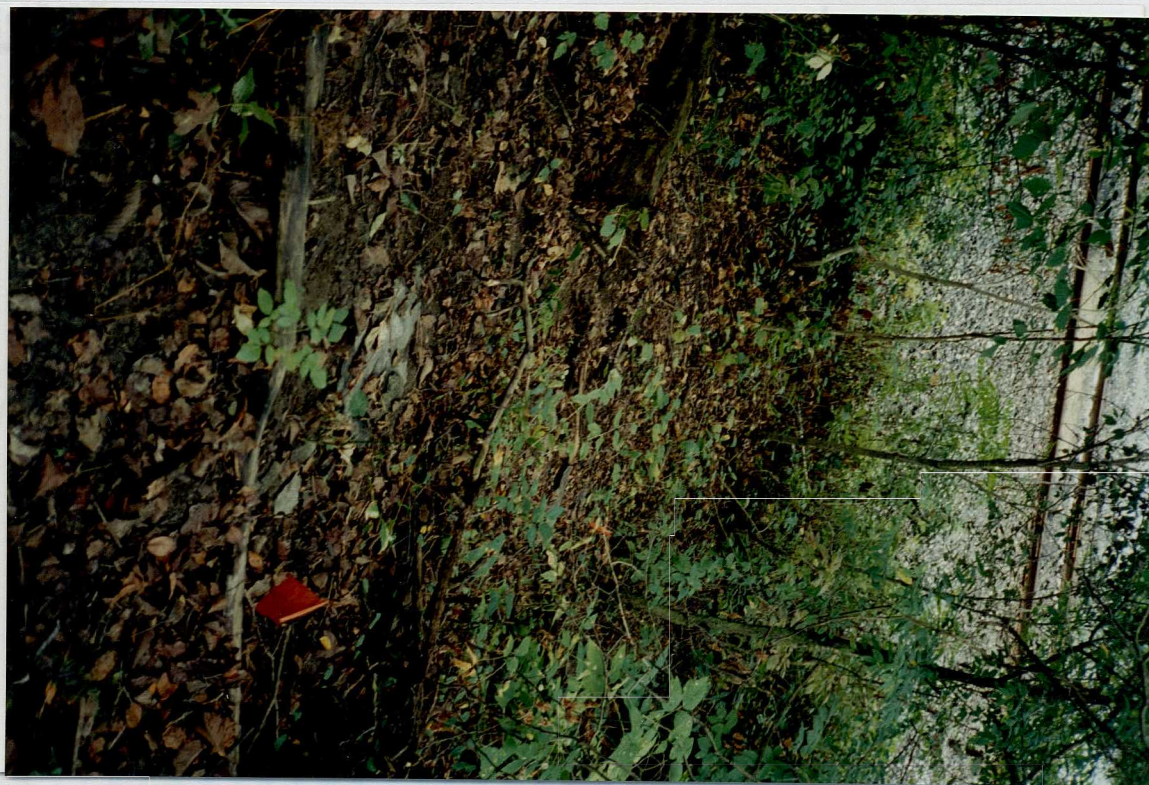
SITE: Tilton Plating DATE: September 25, 1998 TIME: 1055
 LOCATION: Tilton, Illinois DIRECTION: West PHOTOGRAPHER: Bill Sass
 SUBJECT: Sparsely vegetated drop-off to ravine on west side of building.

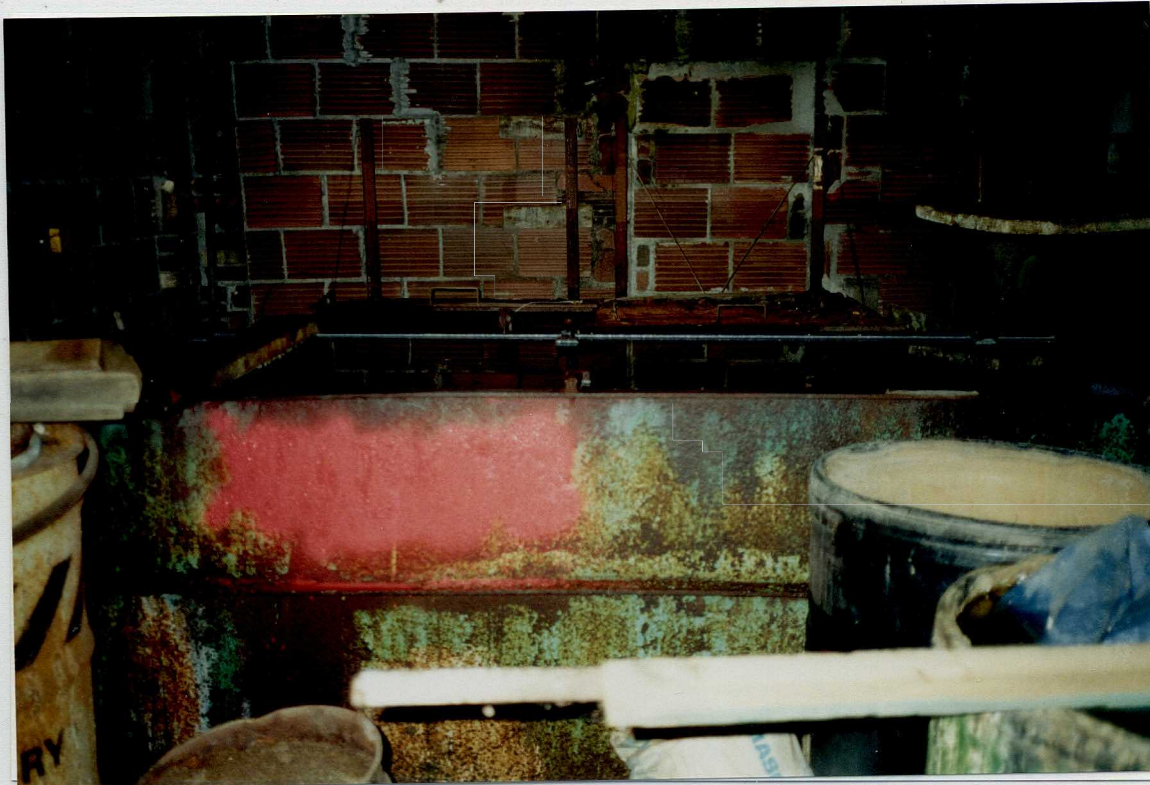
SITE: Tilton Plating **DATE:** September 25, 1998
LOCATION: Tilton, Illinois **DIRECTION:** West
SUBJECT: Vat filled with liquid in building.

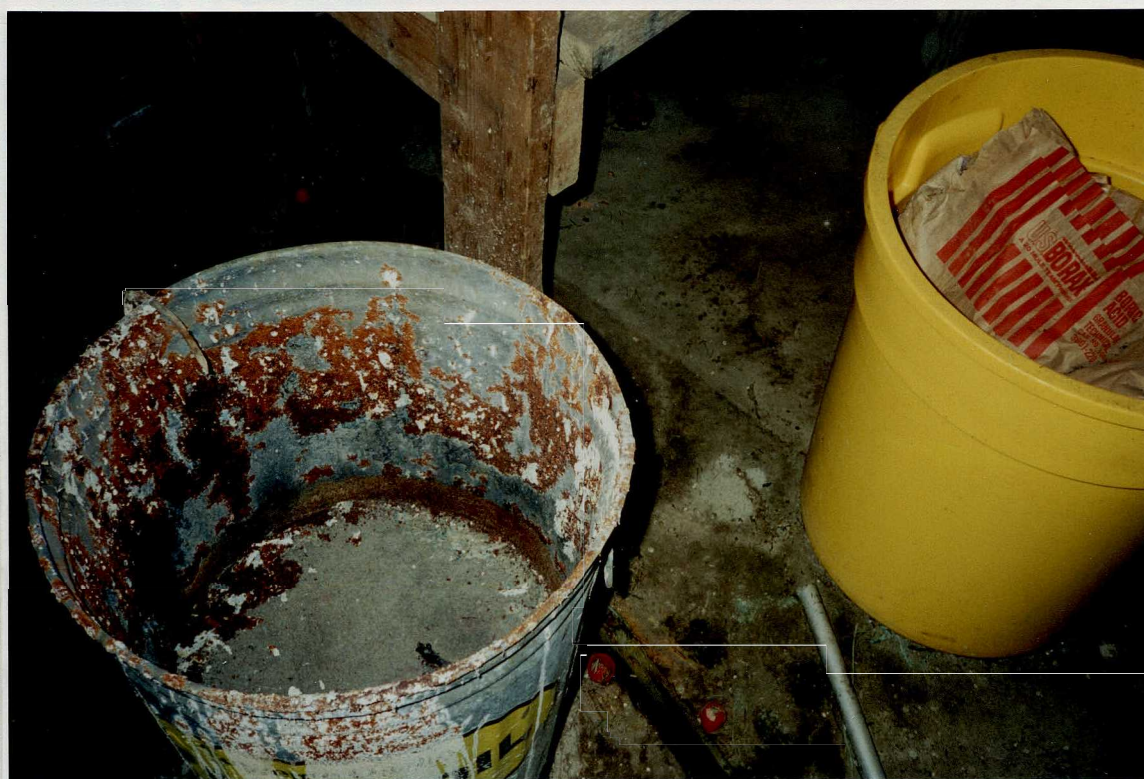
SITE: Tilton Plating **DATE:** September 25, 1998 **TIME:** 1205
LOCATION: Tilton, Illinois **DIRECTION:** Southwest **PHOTOGRAPHER:** P. Atkociunas
SUBJECT: Two open containers in building. One contains boric acid (right) and the other contains an unknown solid.

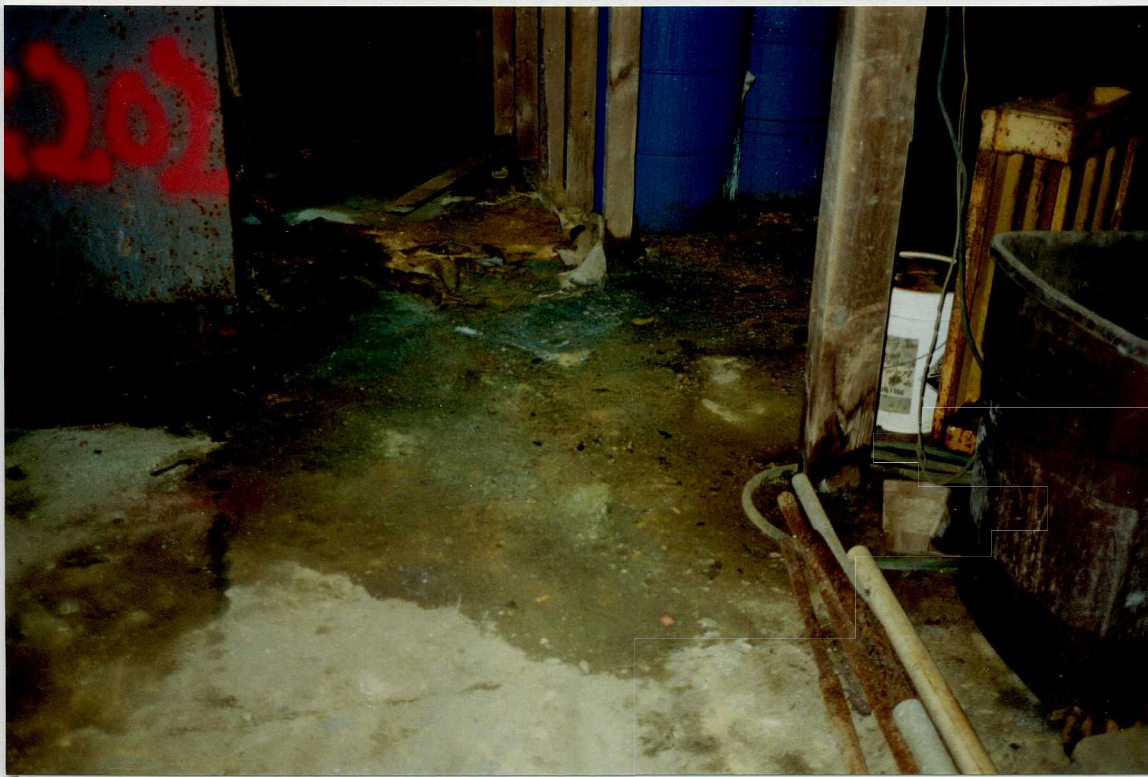
SUBJECT: Floor of building with blue and yellow staining.

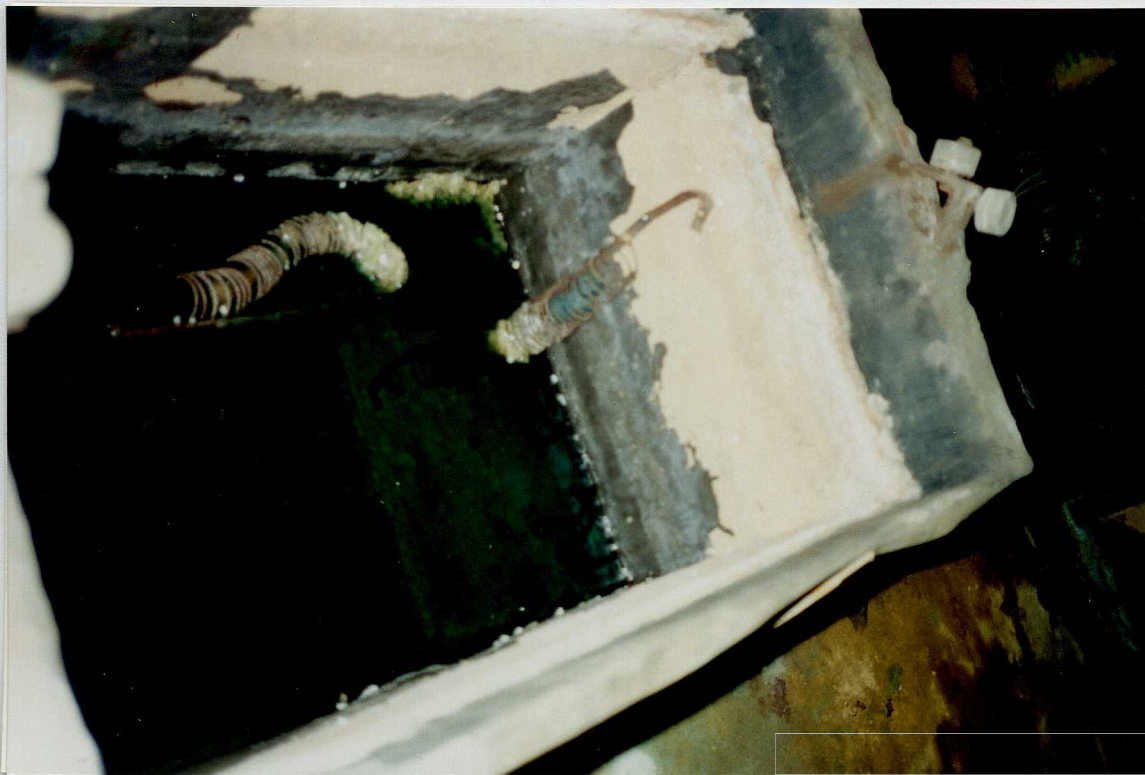
SUBJECT: Green liquid in vat.

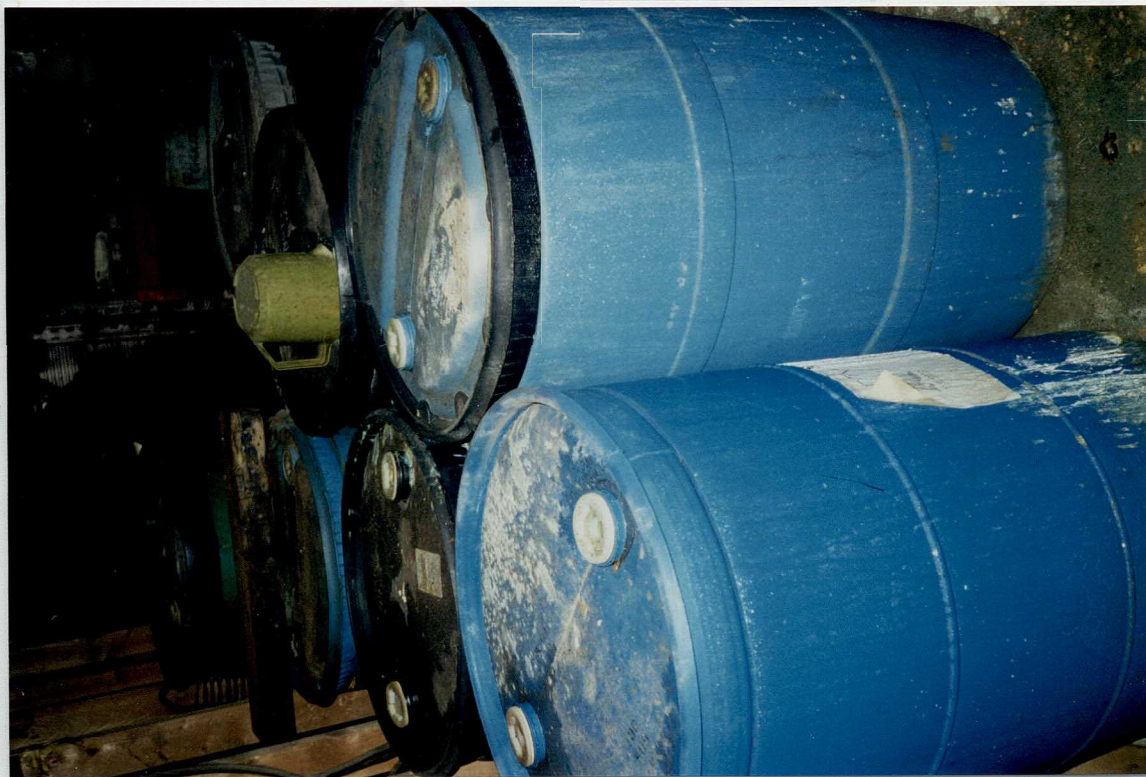
SITE: Tilton Plating **DATE:** September 25, 1998 **TIME:** 1207
LOCATION: Tilton, Illinois **DIRECTION:** West **PHOTOGRAPHER:** P. Atkociunas
SUBJECT: Drums inside building.

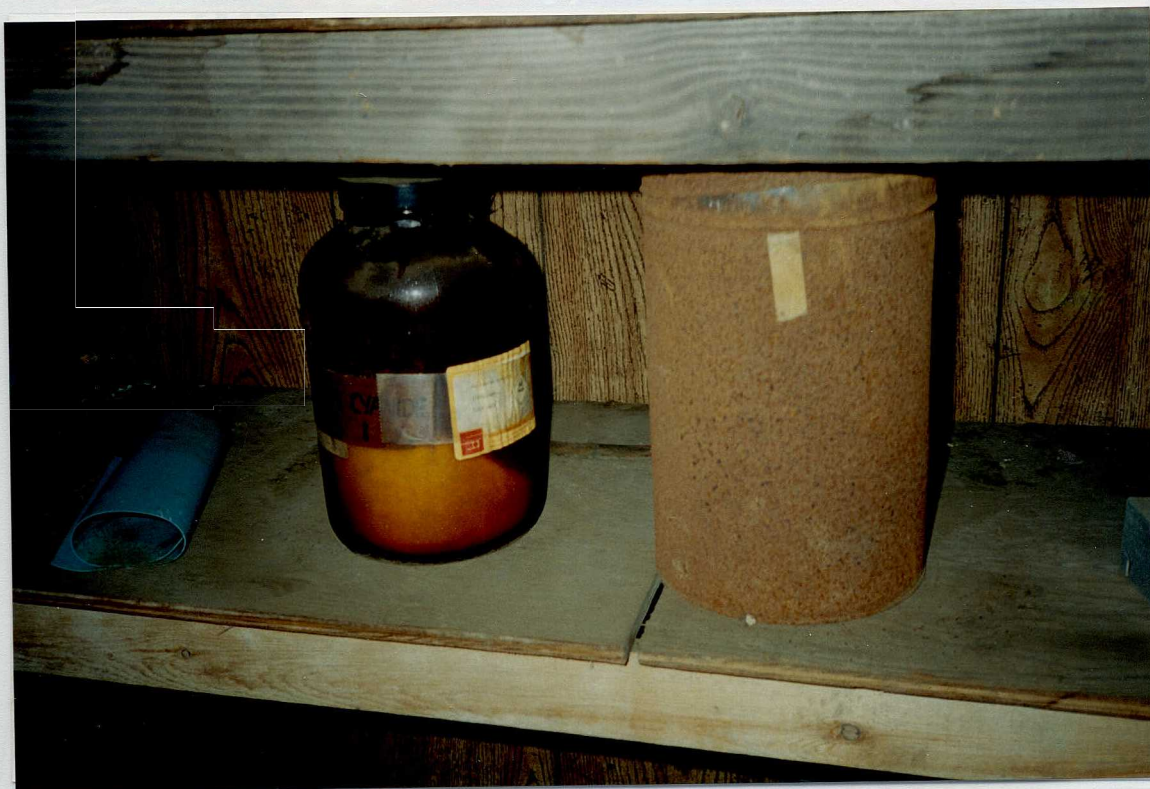
SITE: Tilton Plating **DATE:** September 25, 1998 **TIME:** 1208
LOCATION: Tilton, Illinois **DIRECTION:** East **PHOTOGRAPHER:** P. Atkociunas
SUBJECT: Jar labeled "Potassium Cyanide".

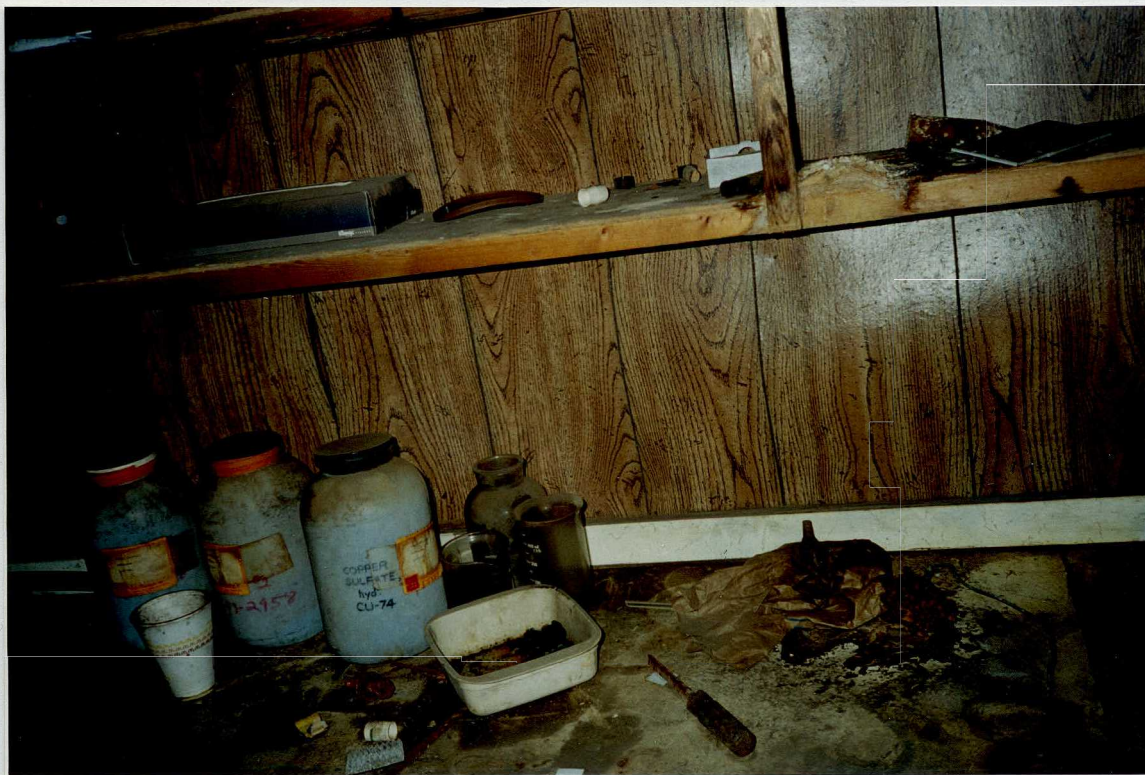
SITE: Tilton Plating DATE: September 25, 1998 TIME: 1208
 LOCATION: Tilton, Illinois DIRECTION: East PHOTOGRAPHER: P. Atkociunas
 SUBJECT: Containers inside building. One is labeled "Copper Sulfate".

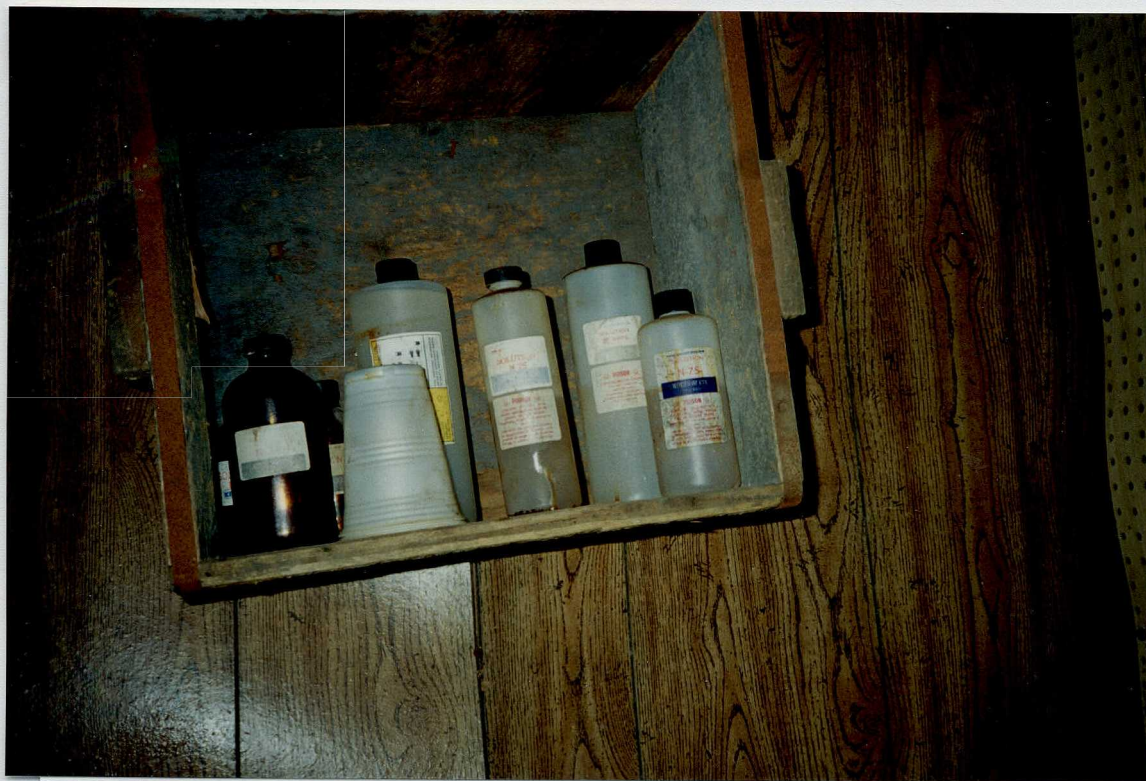
SITE: Tilton Plating DATE: September 25, 1998 TIME: 1208
 LOCATION: Tilton, Illinois DIRECTION: West PHOTOGRAPHER: P. Atkociunas
 SUBJECT: Chemicals in the laboratory.

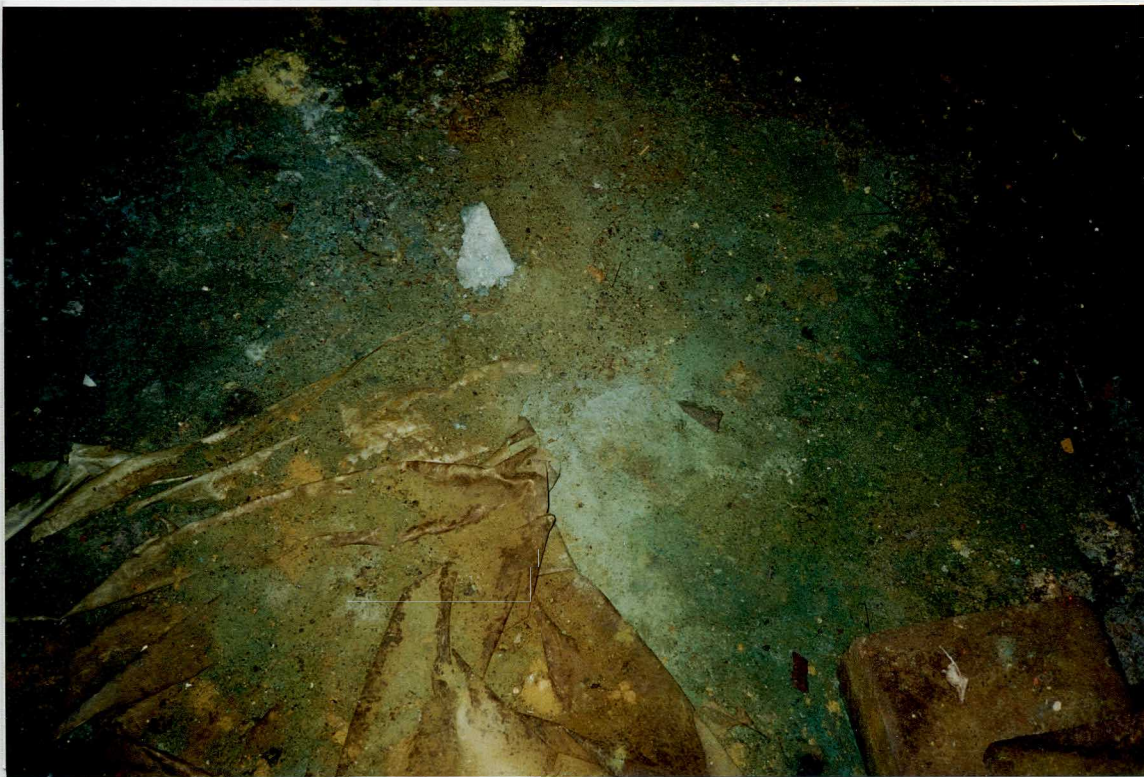
SITE: Tilton Plating **DATE:** September 25, 1998 **TIME:** 1210
LOCATION: Tilton, Illinois **DIRECTION:** Down **PHOTOGRAPHER:** P. Atkociunas
SUBJECT: Blue staining of building floor.

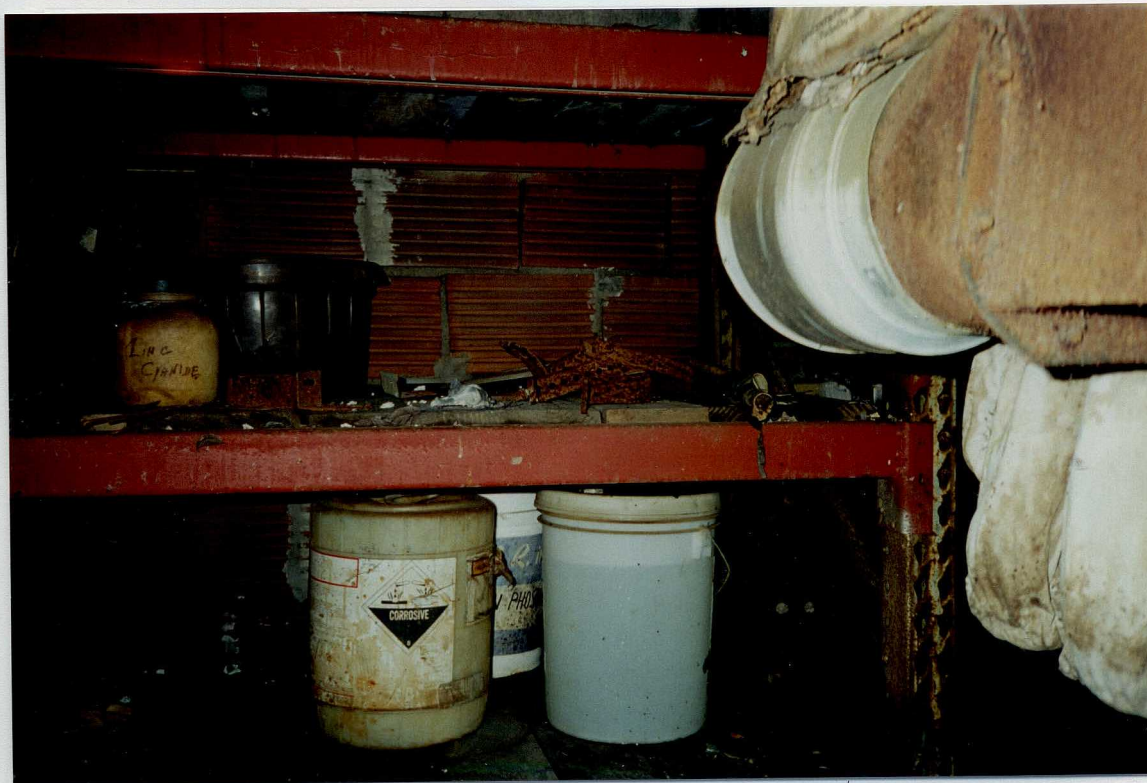
SITE: Tilton Plating **DATE:** September 25, 1998 **TIME:** 1211
LOCATION: Tilton, Illinois **DIRECTION:** West **PHOTOGRAPHER:** P. Atkociunas
SUBJECT: Containers. One is labeled "Zinc Cyanide", which field-tested positive for cyanide, and another is labeled "Corrosive".
